Manhole Inspection Summary

Manhole # S65I__028MH

Record Plat: **651** Node: **028** Status: **New Manhole (Not in GIS)** Insp Date: **1/15/08 9:00 AM**

Location Address: **535 Dundalk Ave.**

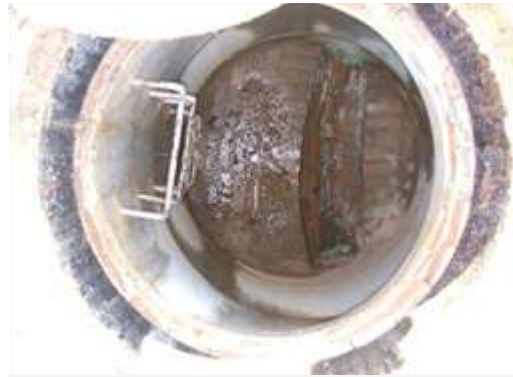
Top View

Condition: ☐ Sound ☐ Cracked ☐ Root Intrusion ☐ Loose Brick ☒ **Deteriorated**

Infiltration: ☐ None ☐ Joint ☐ Cracks ☒ **Mortar** ☐ Roots ☐ Wall
